ANNUAL REPORT FOR 2011

Bear Branch Mitigation Site Brunswick County TIP No. B-4030

Prepared By:
Natural Environment Unit & Roadside Environmental Unit
North Carolina Department of Transportation
July 2011

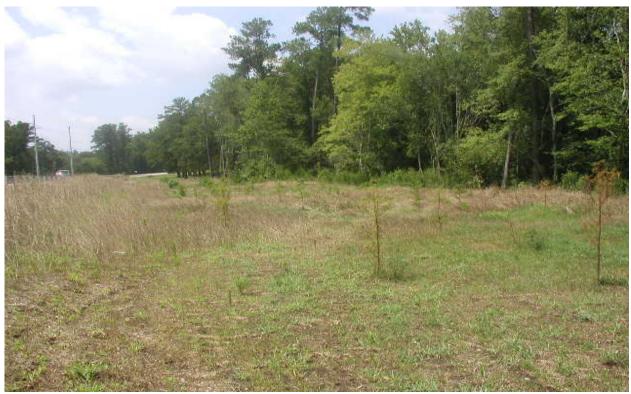
Photo 1

There were approximately 0.41 acres of riparian wetland restoration on site. There were no plots established on the site. By visual observation, the Bear Branch Mitigation Site shows that the planted species are surviving in the planted area and that the restoration area is re-attaining wetland jurisdictional status.

NCDOT proposes to continue vegetation monitoring at the Bear Branch Mitigation Site.

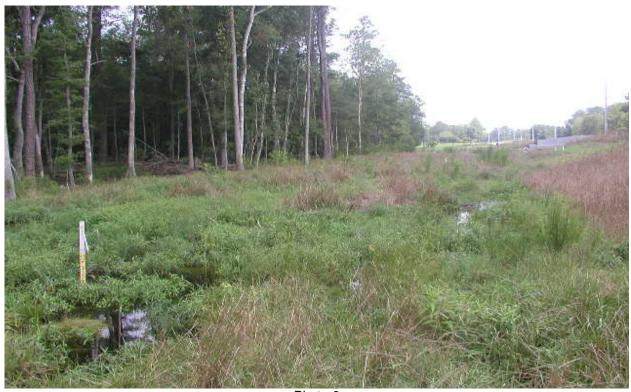
Photo 2

The restoration area is re-attaining wetland jurisdictional status and the planted species are surviving. Blackgum, baldcypress, and green ash were noted surviving on site. Pockets of standing water were noted on the north side of Bear Branch as seen in Photo 2.
